Substantial Damage Estimation

Using Hazus-MH as a Screening Tool
After Hurricane Harvey

Stephen Veith

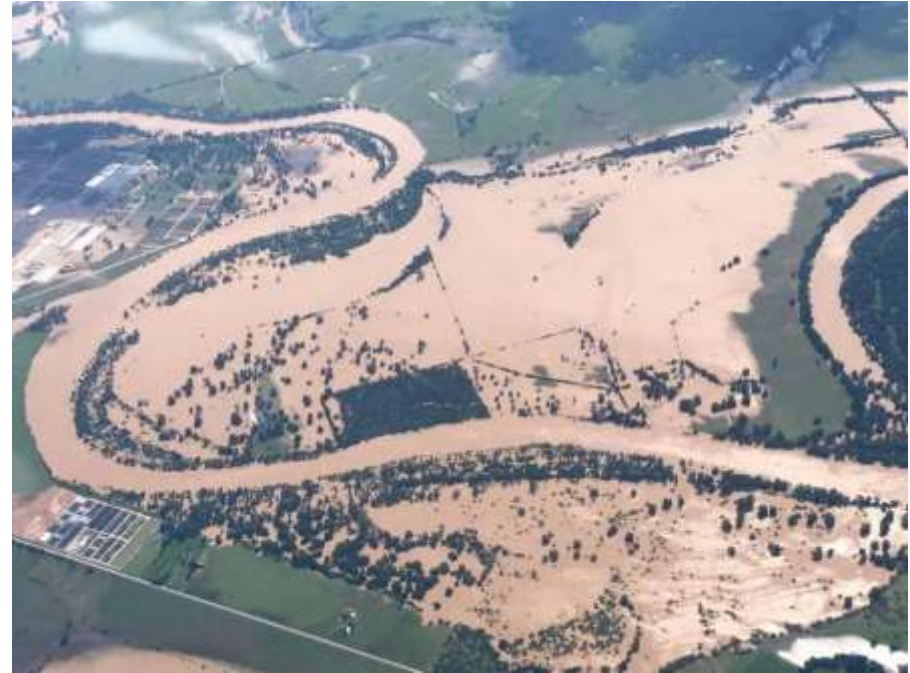
- Normal Brazos river height fluctuates between 10 and 20 feet
- River crests on the Brazos at Richland, TX ~55 feet
- Normal flow between 3,000 – 12,000 cubic feet per second
- Flood events reached over 110,000 cubic feet per second

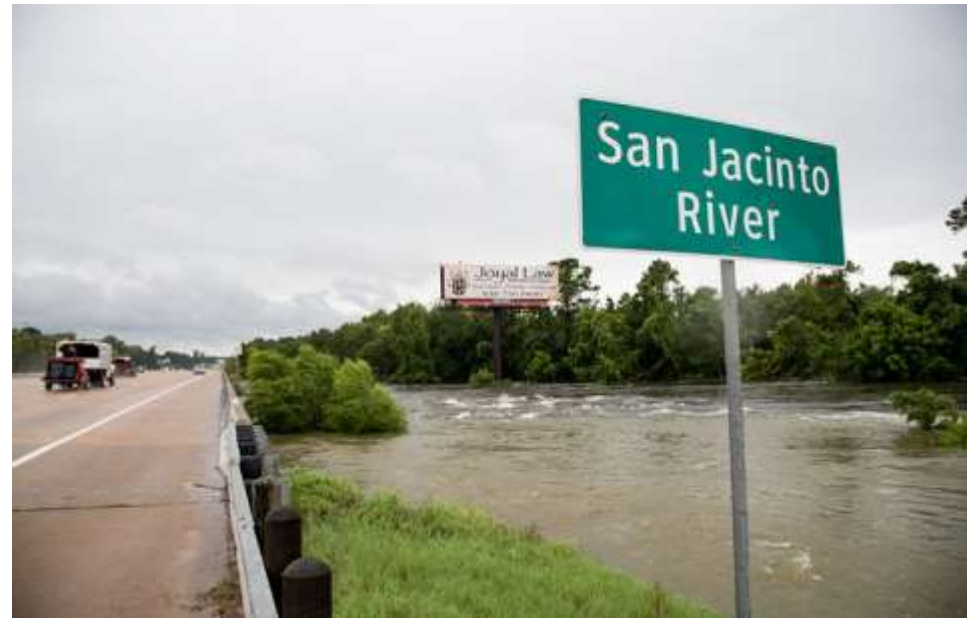
- Normal San Jacinto (West Fork) river height fluctuates around 15 feet
- River crests on the West Fork San Jacinto river at Conroe, TX ~47 feet
- Normal flow from 100 to 1,000 cubic feet per second
- Flood events reached over 80,000 cubic feet per second

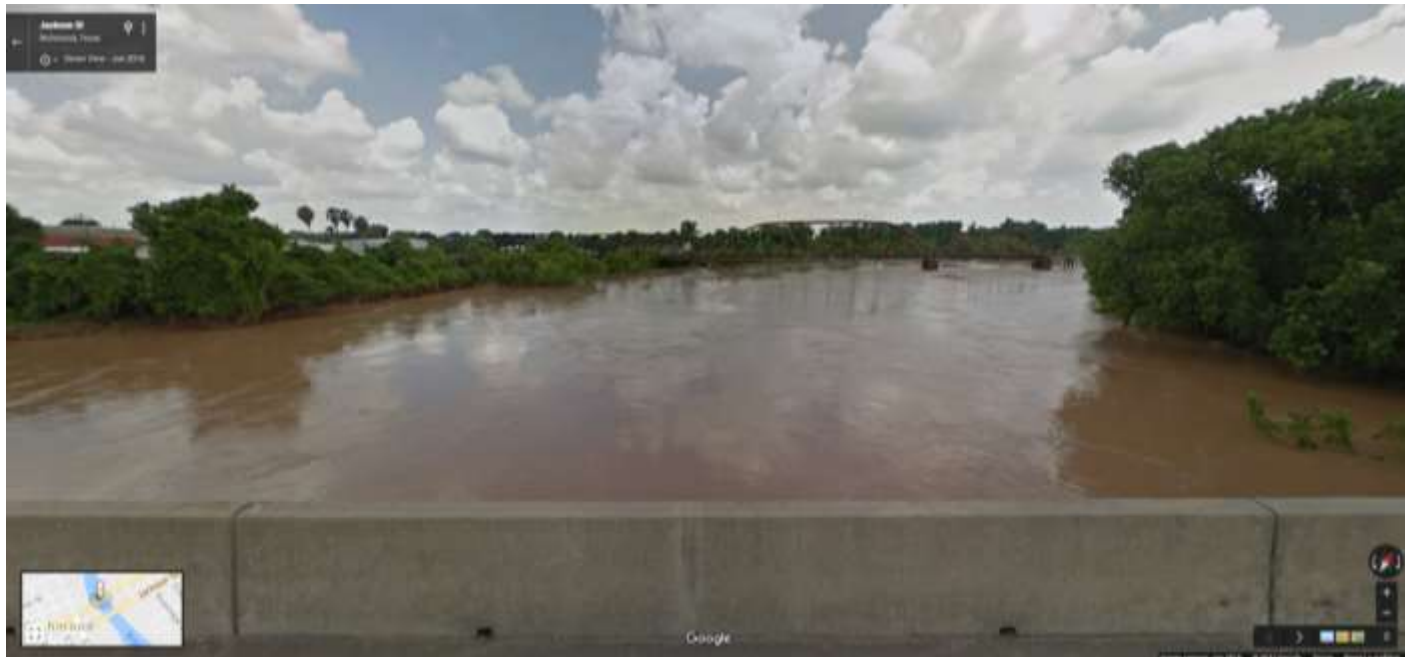
- Re-create Hurricane Harvey flood scenario and compare against building inventory
- End goal is to estimate number and location of buildings that are substantially damaged (>50% to structure)

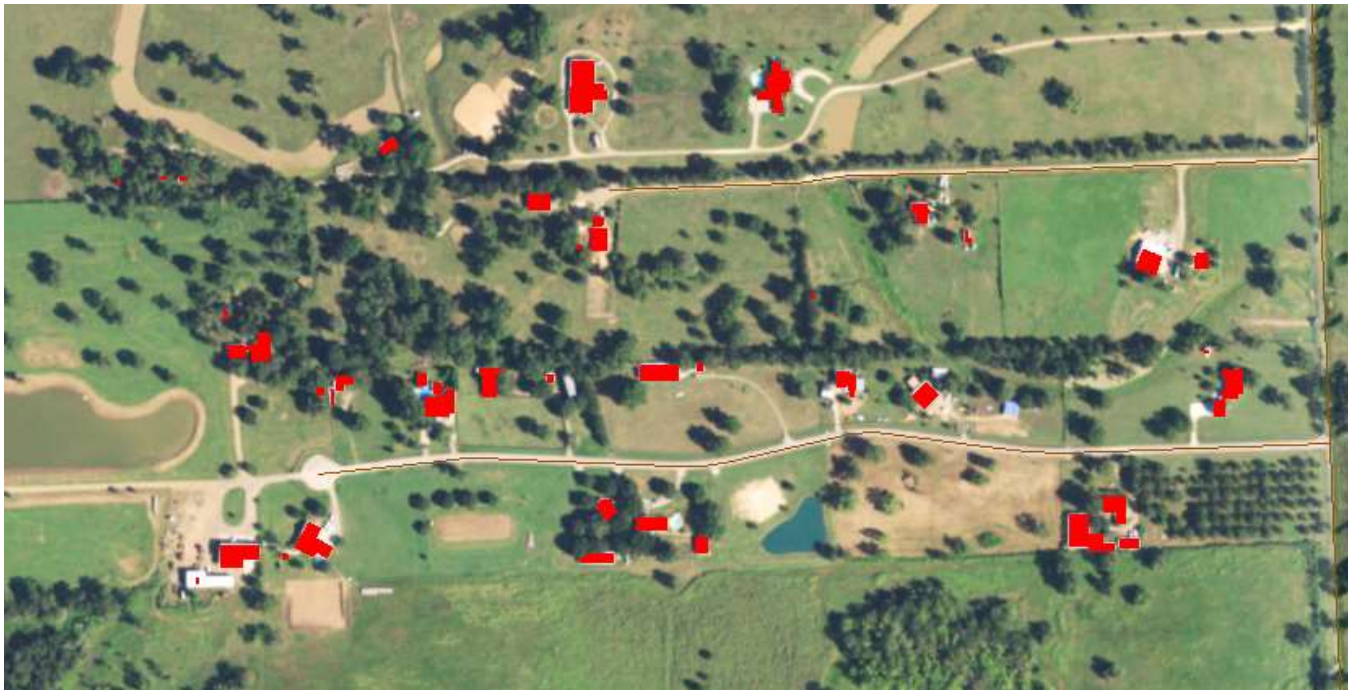
- LiDAR Building Footprints
 - Allow much more accurate spatial location building points within Hazus model

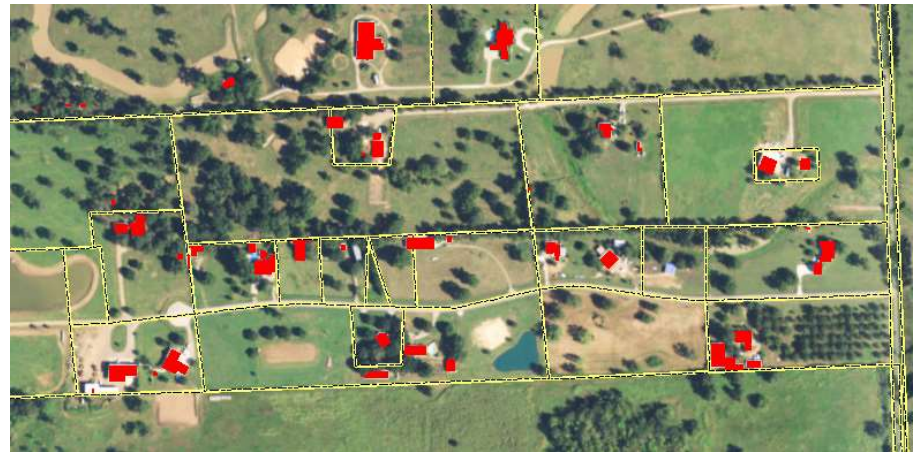
- Solution: Use “Main Area” improvement to tie to all building points within that parcel
- If no “Main Area” improvement, then attach highest assessed value to the parcel building points
- Focuses on generating substantially damaged estimates for the main structure/residence of a parcel
- Also add field identifying if a building is the largest structure on that parcel

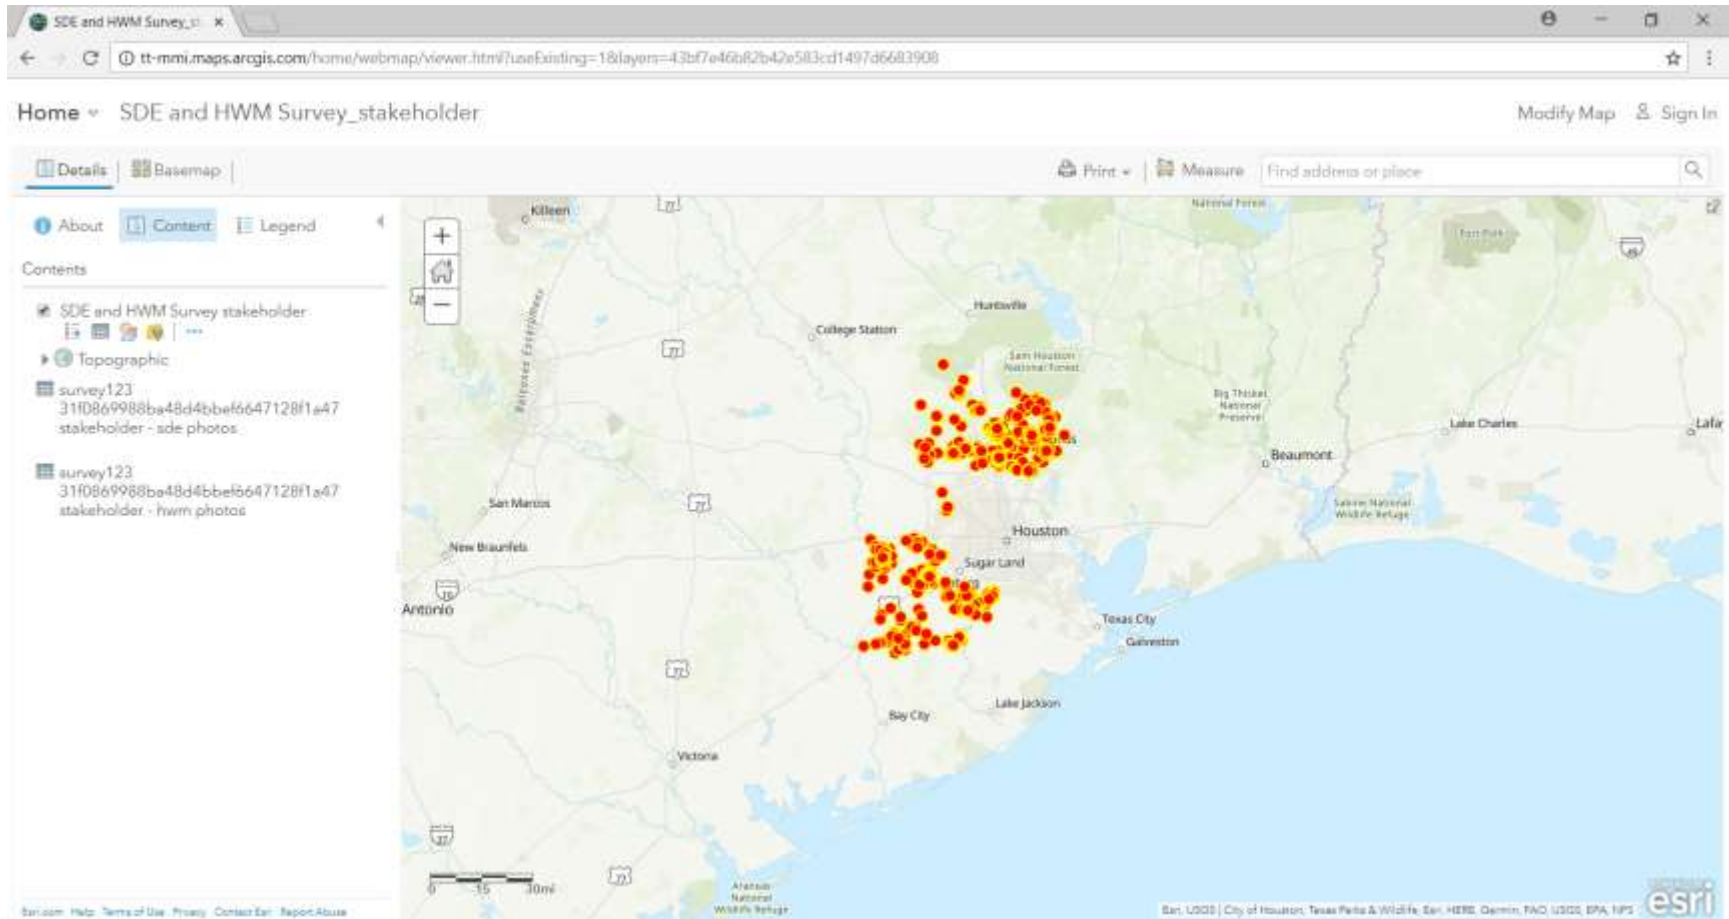
The screenshot displays a web browser window with the URL `tt-mmi.maps.arcgis.com/home/webmap/viewer.html?useExisting=1&layers=43bf7e46b82b42e583cd1497d6683908`. The page title is "Home - SDE and HWM Survey_stakeholder".

On the left side, there is a navigation pane with tabs for "Details", "Basemap", "About", "Content", and "Legend". Under the "Content" tab, the following layers are listed:

- SDE and HWM Survey stakeholder
- Topographic
- survey123
31f0869988ba48d4bbef6647128f1a47
stakeholder - sde photos
- survey123
31f0869988ba48d4bbef6647128f1a47
stakeholder - hwm photos

The main map area shows a geographic view of Texas with red circular markers clustered around Houston and Sugar Land. The map includes various geographical features like cities (Killeen, College Station, Houston, Sugar Land, Texas City, Galveston, Victoria, San Antonio, New Braunfels, San Marcos, Austin, Dallas, Fort Worth, San Antonio, Houston, Sugar Land, Texas City, Galveston, Victoria, Boy City, Lake Jackson, Beaumont, Lake Charles, Lufkin), water bodies (Gulf of Mexico, Lake Jackson, Lake Charles), and parks (Sam Houston National Forest, Big Thicket National Preserve, Lake National Wildlife Refuge, Atascosa National Wildlife Refuge). A scale bar at the bottom left indicates 0, 10, and 30 miles. The Esri logo is visible in the bottom right corner.

- Used ArcGIS Online to develop an inspection and high water mark collection database
- Easily accessible by the teams on the ground and clients
- Used Survey 123 to record information
